Executive Summary

Report V1.0

Engineer's Damaged Truss/Timber Evaluation

On 11/12/2025 a Damaged Truss Evaluation (DTE) was performed at the property located at address 123 Main St, Your City, CO, 12345, which consists of a 2600 square-foot single family no garage structure built in 2007 with a truss roof framing.

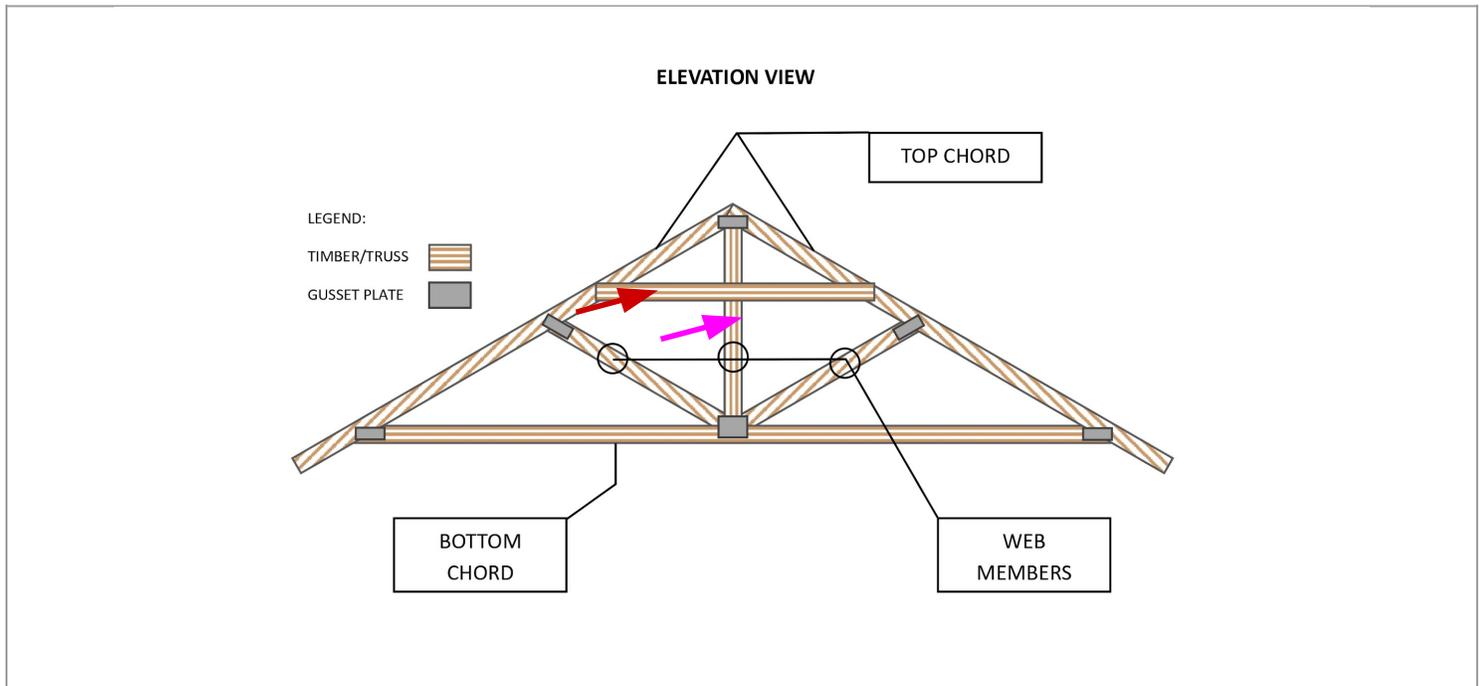
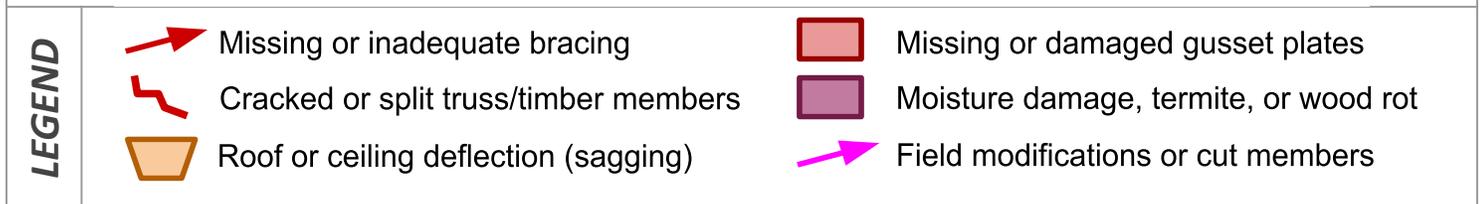
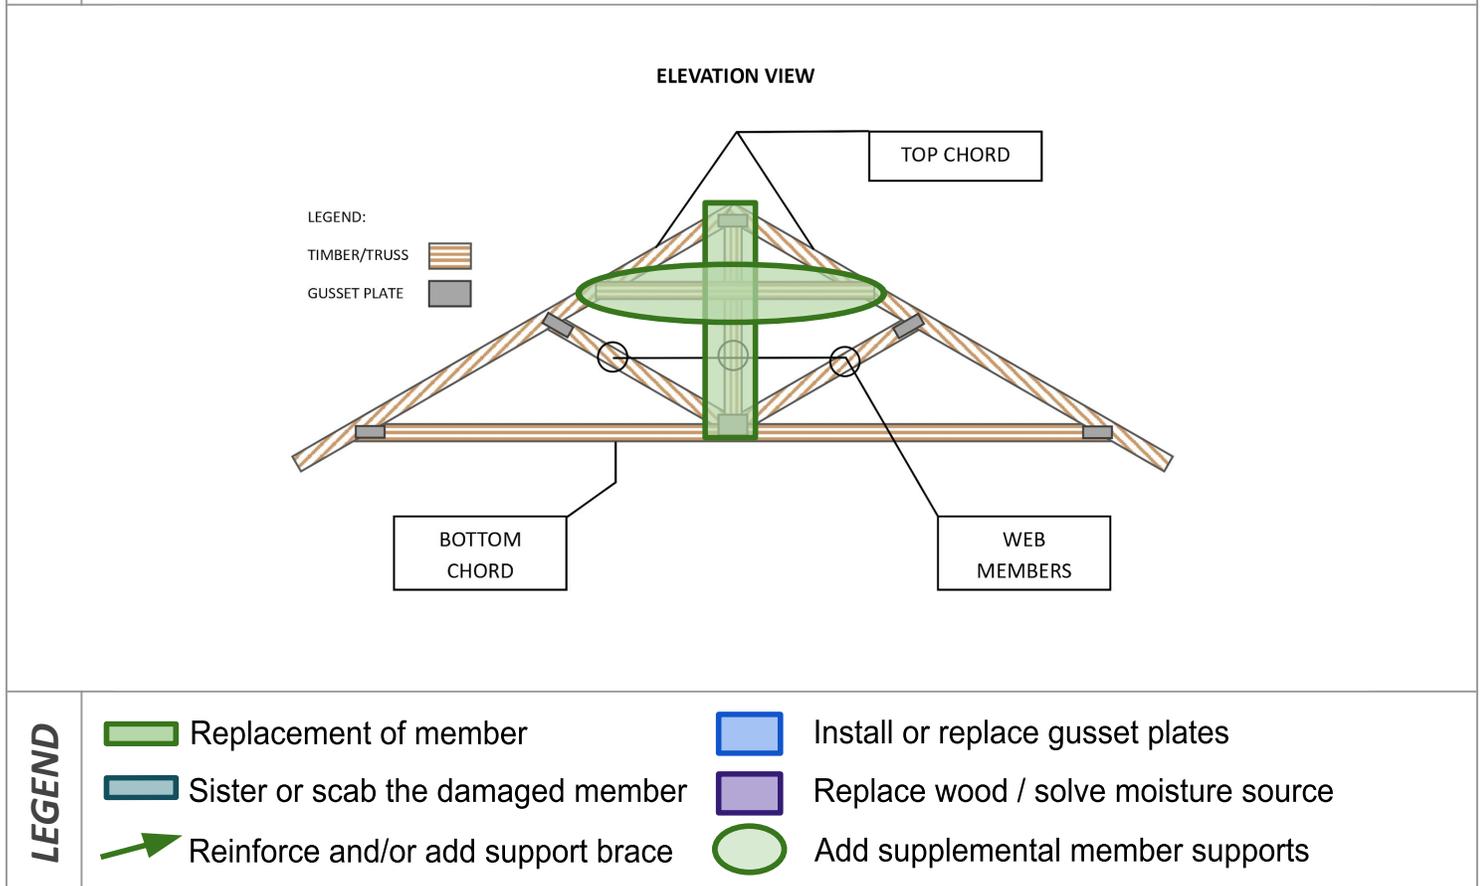
Exhibit A - Damaged Area 1 (Damaged King Post)

Member Deflecting/Bowing: We agree with the findings of the inspection report that the observed bowing of the king post of two truss members should be considered significant (See Exhibit A). The affected members exhibit noticeable bowing along their span, suggesting overstress, insufficient lateral restraint, or deformation due to sustained loading or moisture-related movement. The deflection indicates localized loss of stiffness and potential redistribution of loads within the truss system. While the overall roof structure remains generally intact, the bowed members may have a reduced capacity to maintain proper alignment and resist design loads.

Replacement of Member: For timber or truss member/s showing signs of deflection or bowing, remove the affected member/s and replace it with new dimensional lumber of the same grade and species, but constructed as a triple-laminated member (three 2x members fastened together) for increased capacity (see Exhibit B). Cut the replacement member/s to match the existing configuration and ensure tight bearing at connection points. Secure the new member/s using approved truss plates, gusset plates, or structural screws/bolts consistent with industry standards and truss repair guidelines. Verify that all connections are tight and properly aligned to maintain the original configuration and load path. Add collar ties as necessary, confirming proper connection to the king post, and fasten each collar tie using four (4) 10d common framing nails installed in a standard rectangular pattern, with two nails per row and two rows.
